# Selling Arguments *for* TIN ROOFING

*A review of the advantages of  
roofs of this type*

A textbook containing corrected tables for use in estimating, instructions for laying tin roofs, description of the manufacture of roofing tin, and a large amount of information useful to the practical man.

N. & G. Taylor Company, Philadelphia

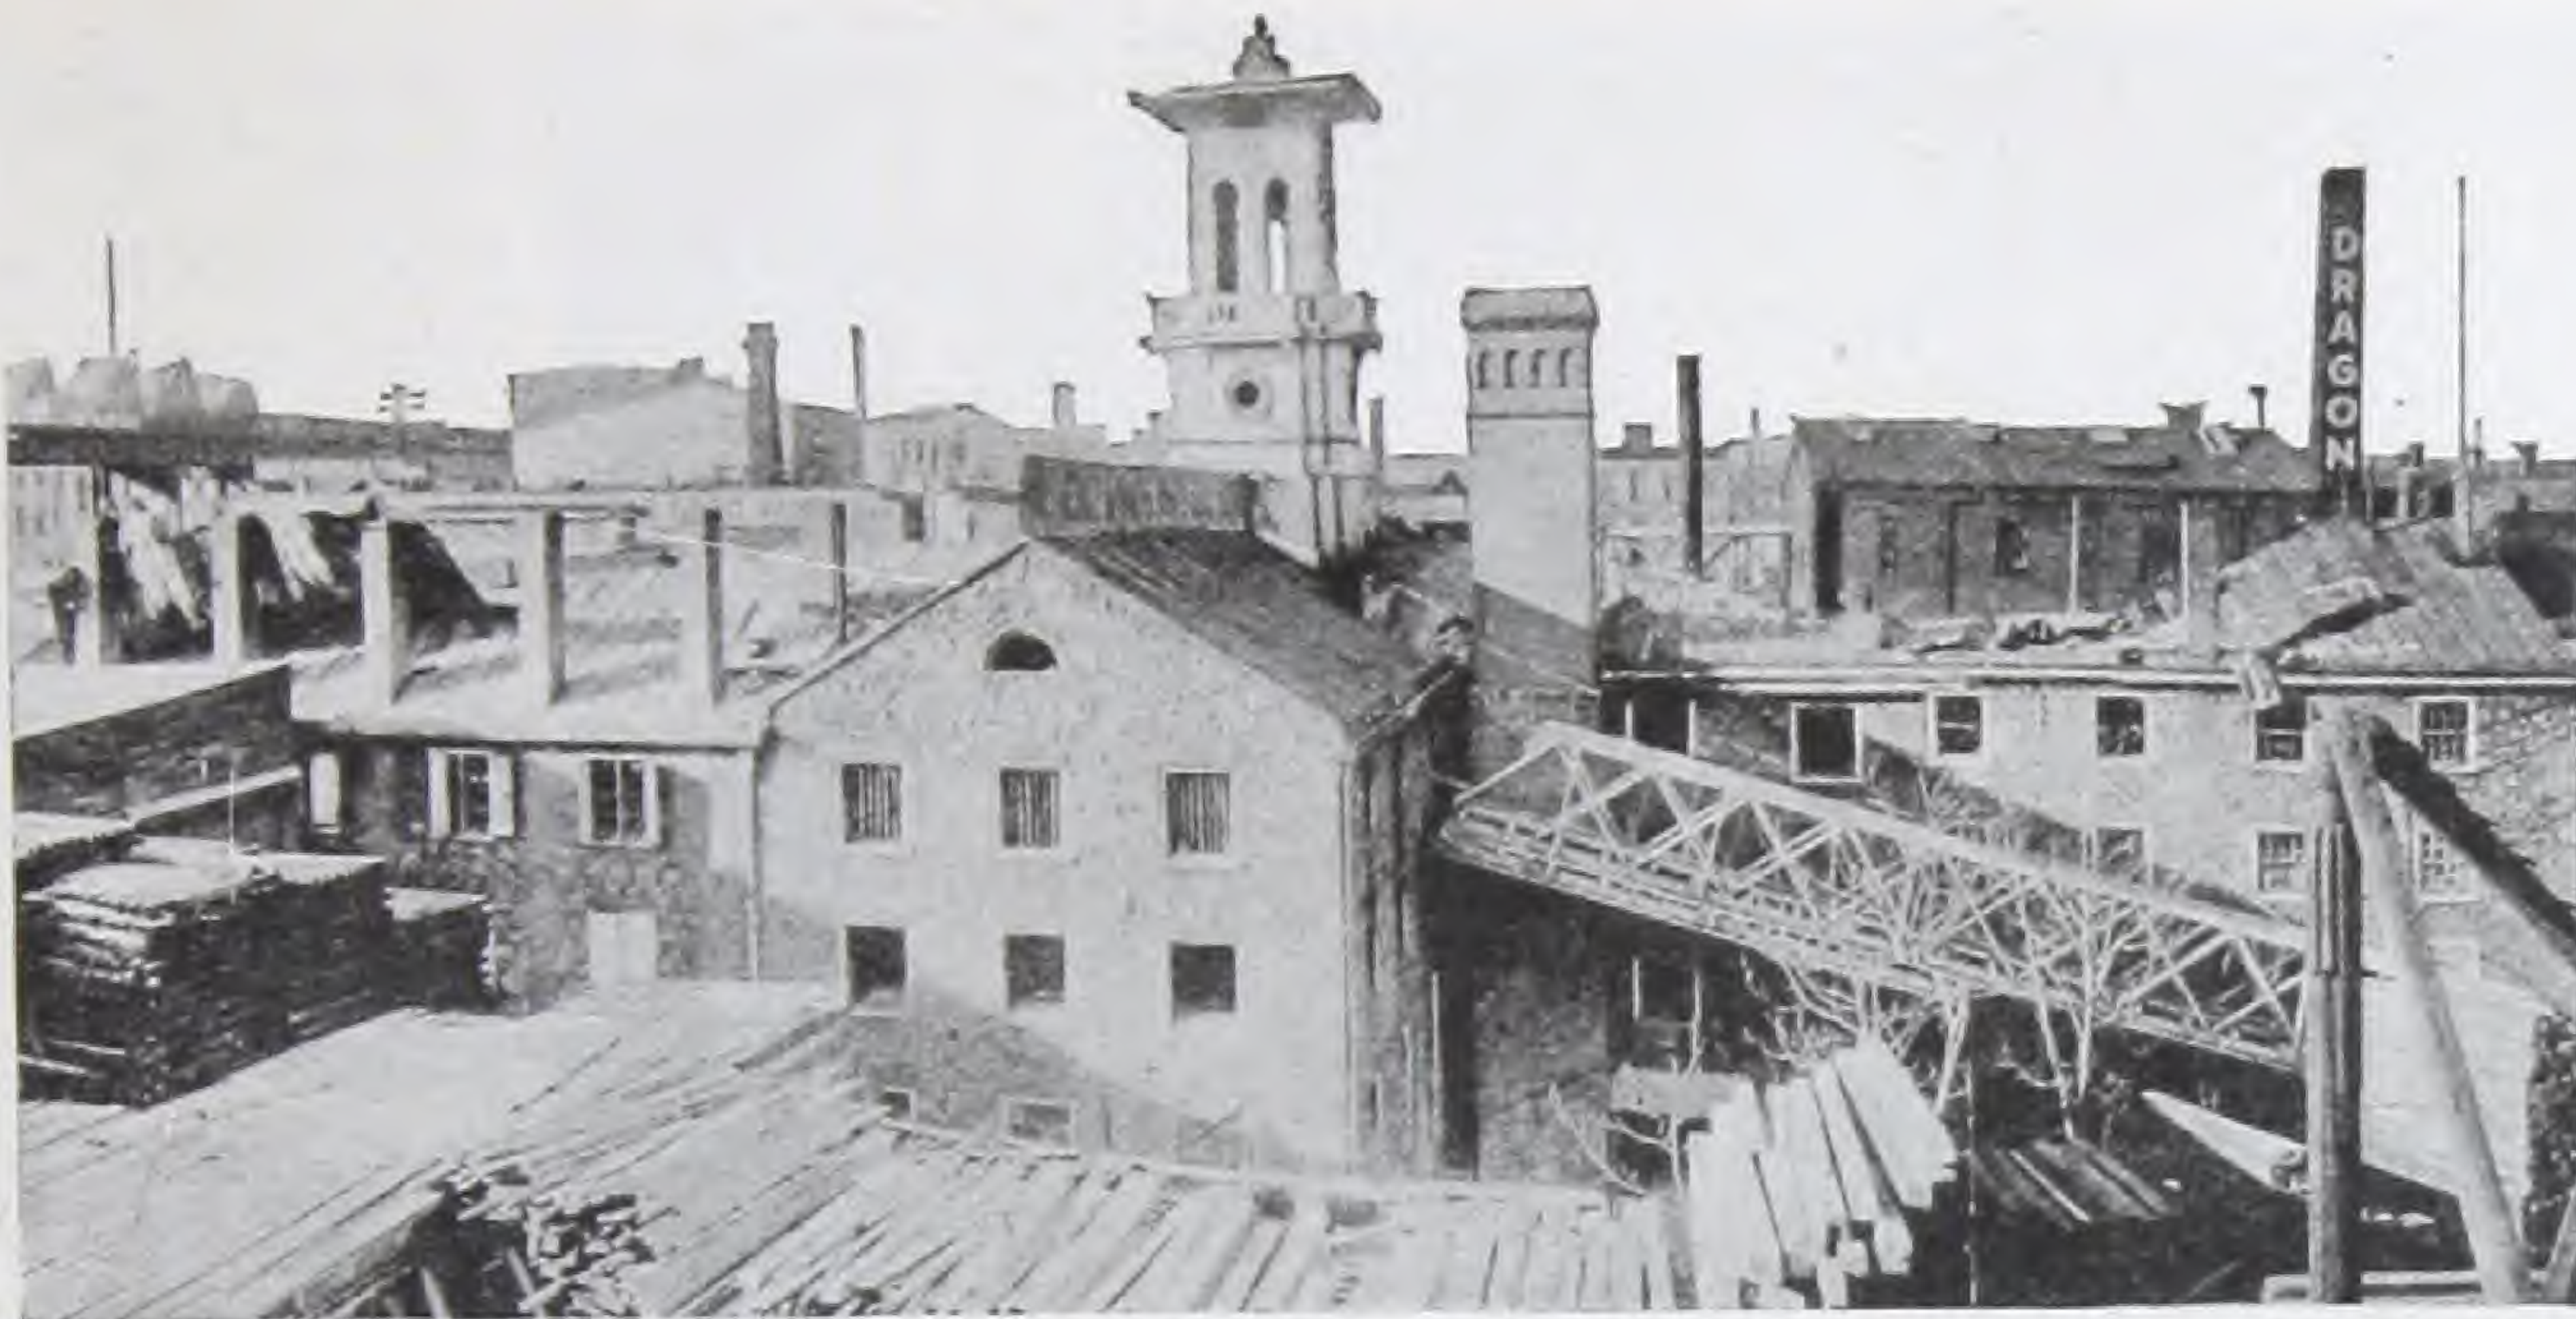
**32. PREVENTS SPREAD OF FIRE:** This photograph shows the white lead works of Wetherill & Brother, in Philadelphia, after a fire in March, 1907. The buildings shown were completely destroyed inside. The floors were burned away, and a part of the roof on the right wing was carried down with the wreckage. Although the heat was intense, and the fire spread with great rapidity through the buildings, the tin roofs remained intact, smothering the flames and preventing their spread to surrounding buildings and to the adjoining lumber yard shown in the photograph. Even the wooden sign on the top of the central building and the wooden clock tower were not reached by the flames. The owners report that these roofs were of the original tin put on the buildings when first erected, *80 years before*, and still in good condition at the time of the fire. After careful investigation, our best tin was selected for re-roofing the buildings.

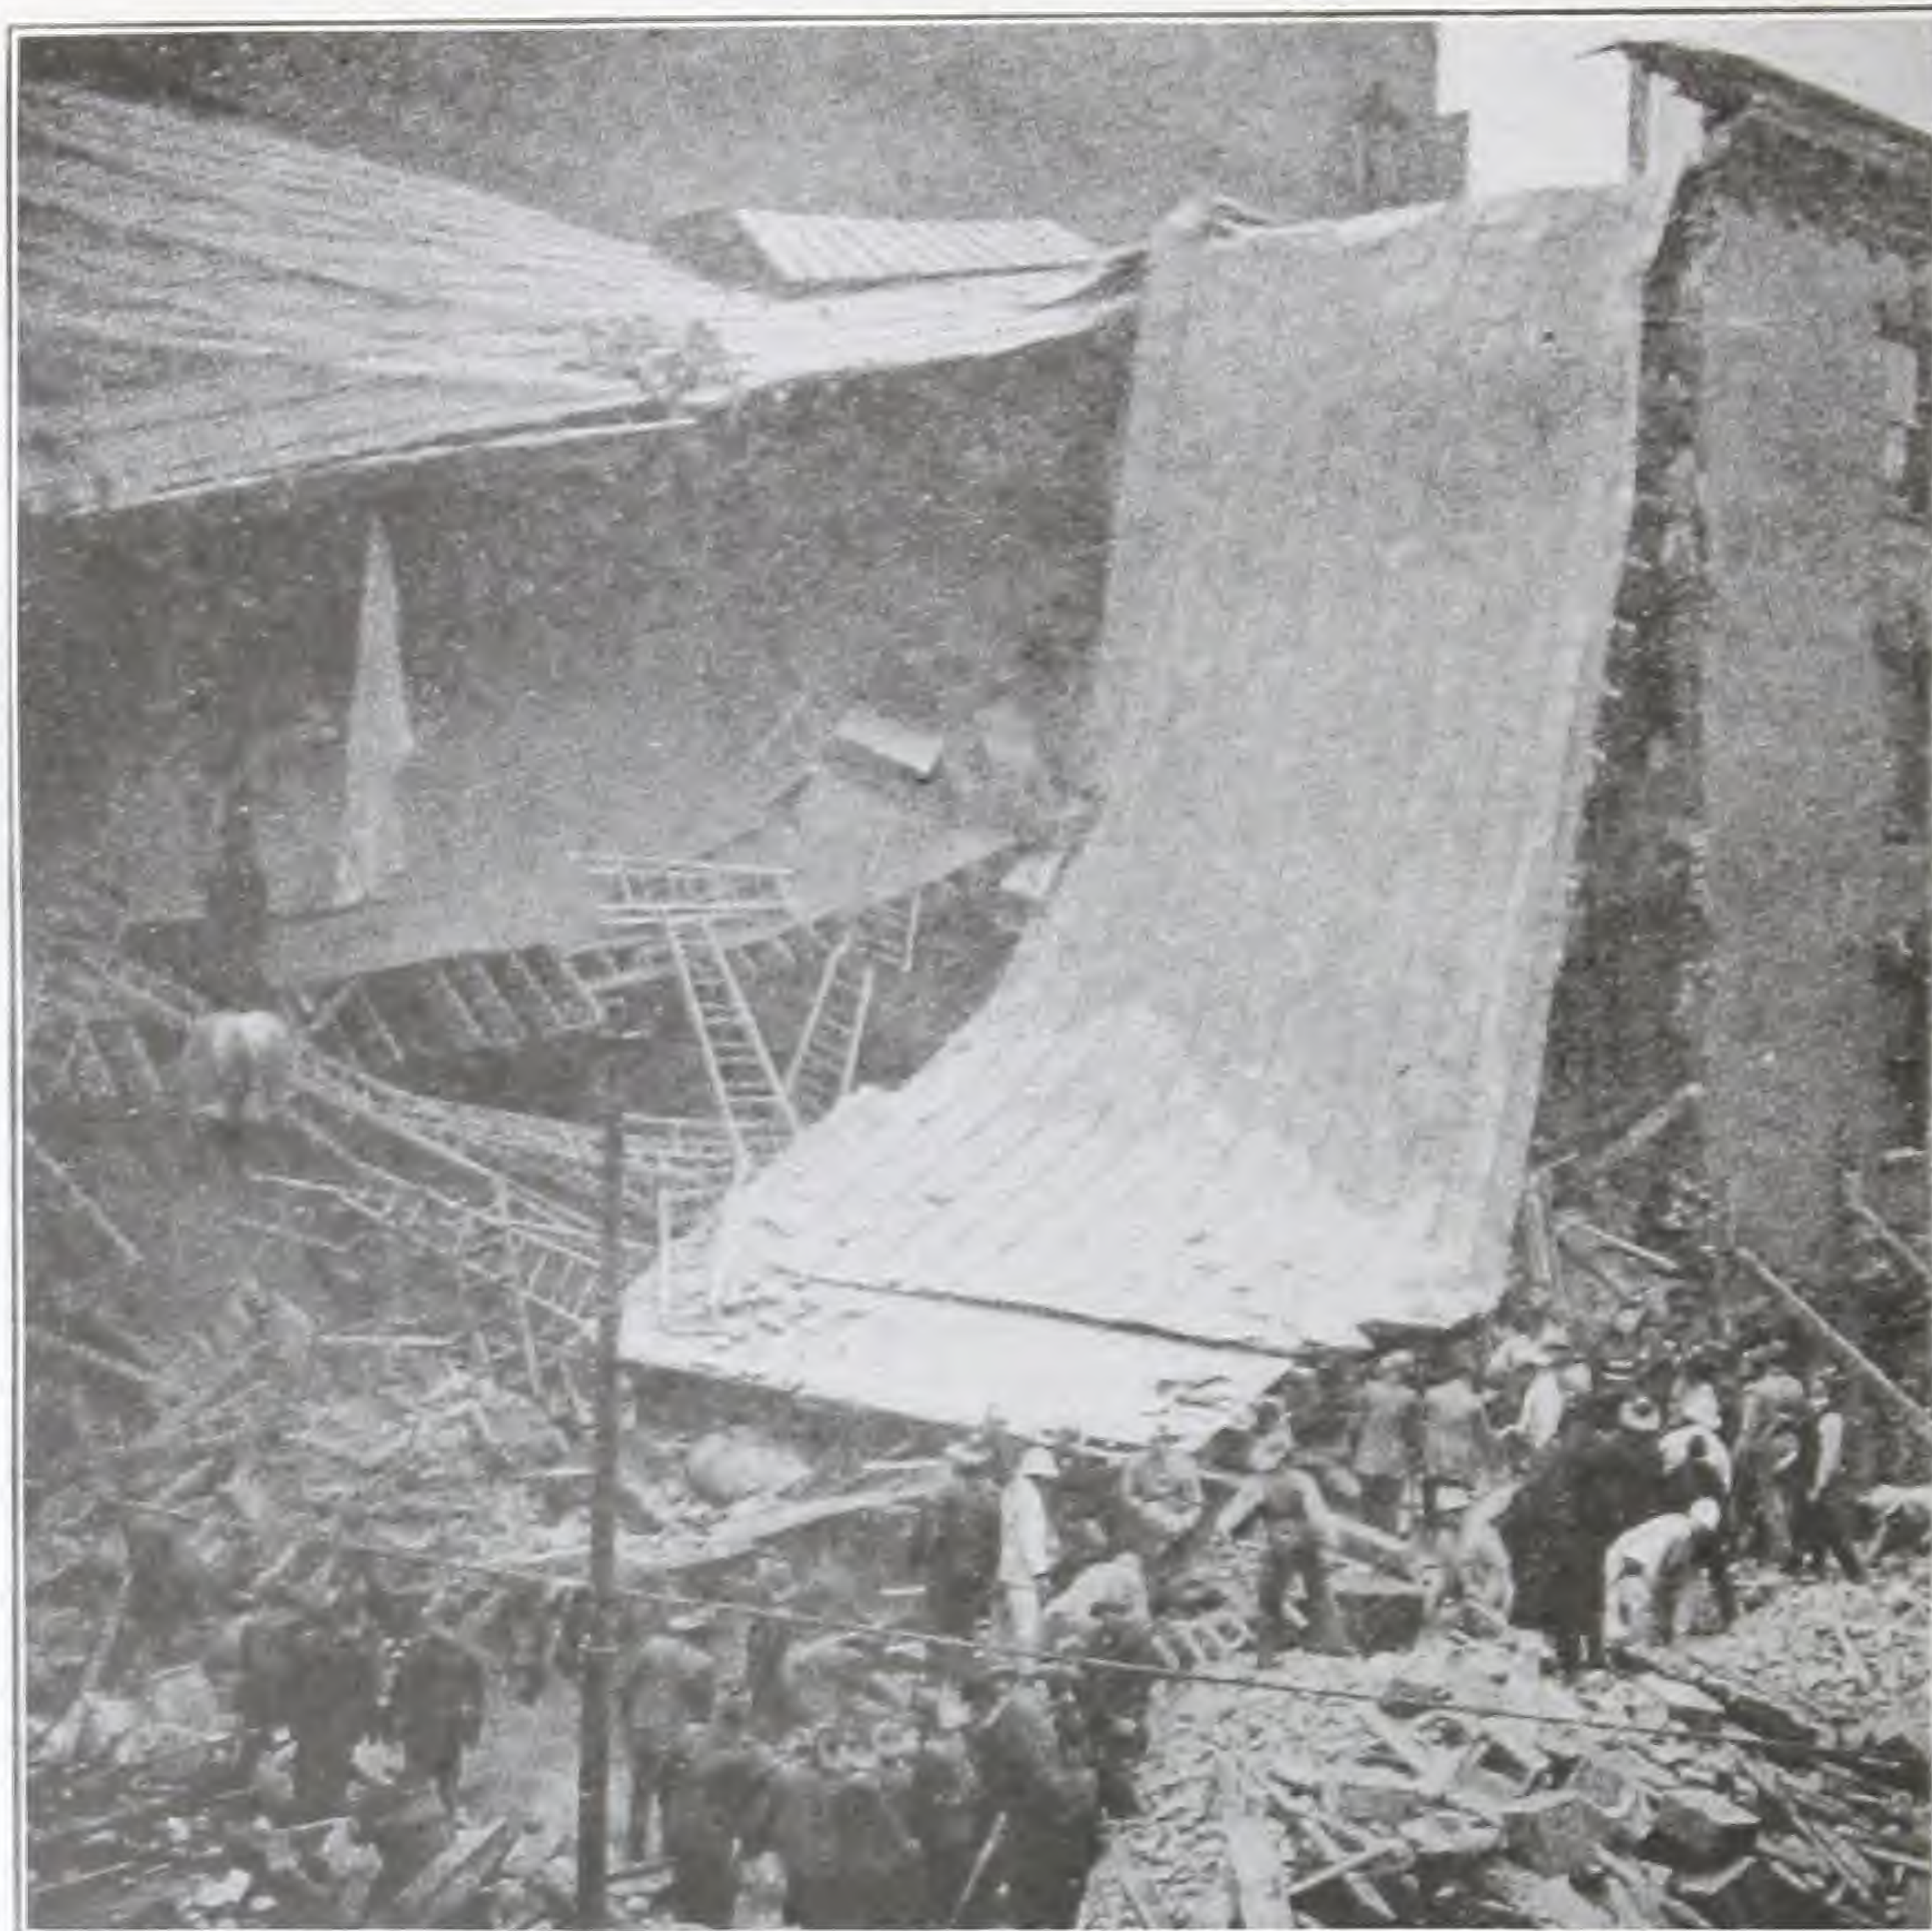
**33. STRENGTH:** This view of a building collapse in Pittsburg serves to show how a tin roof holds together under strain.

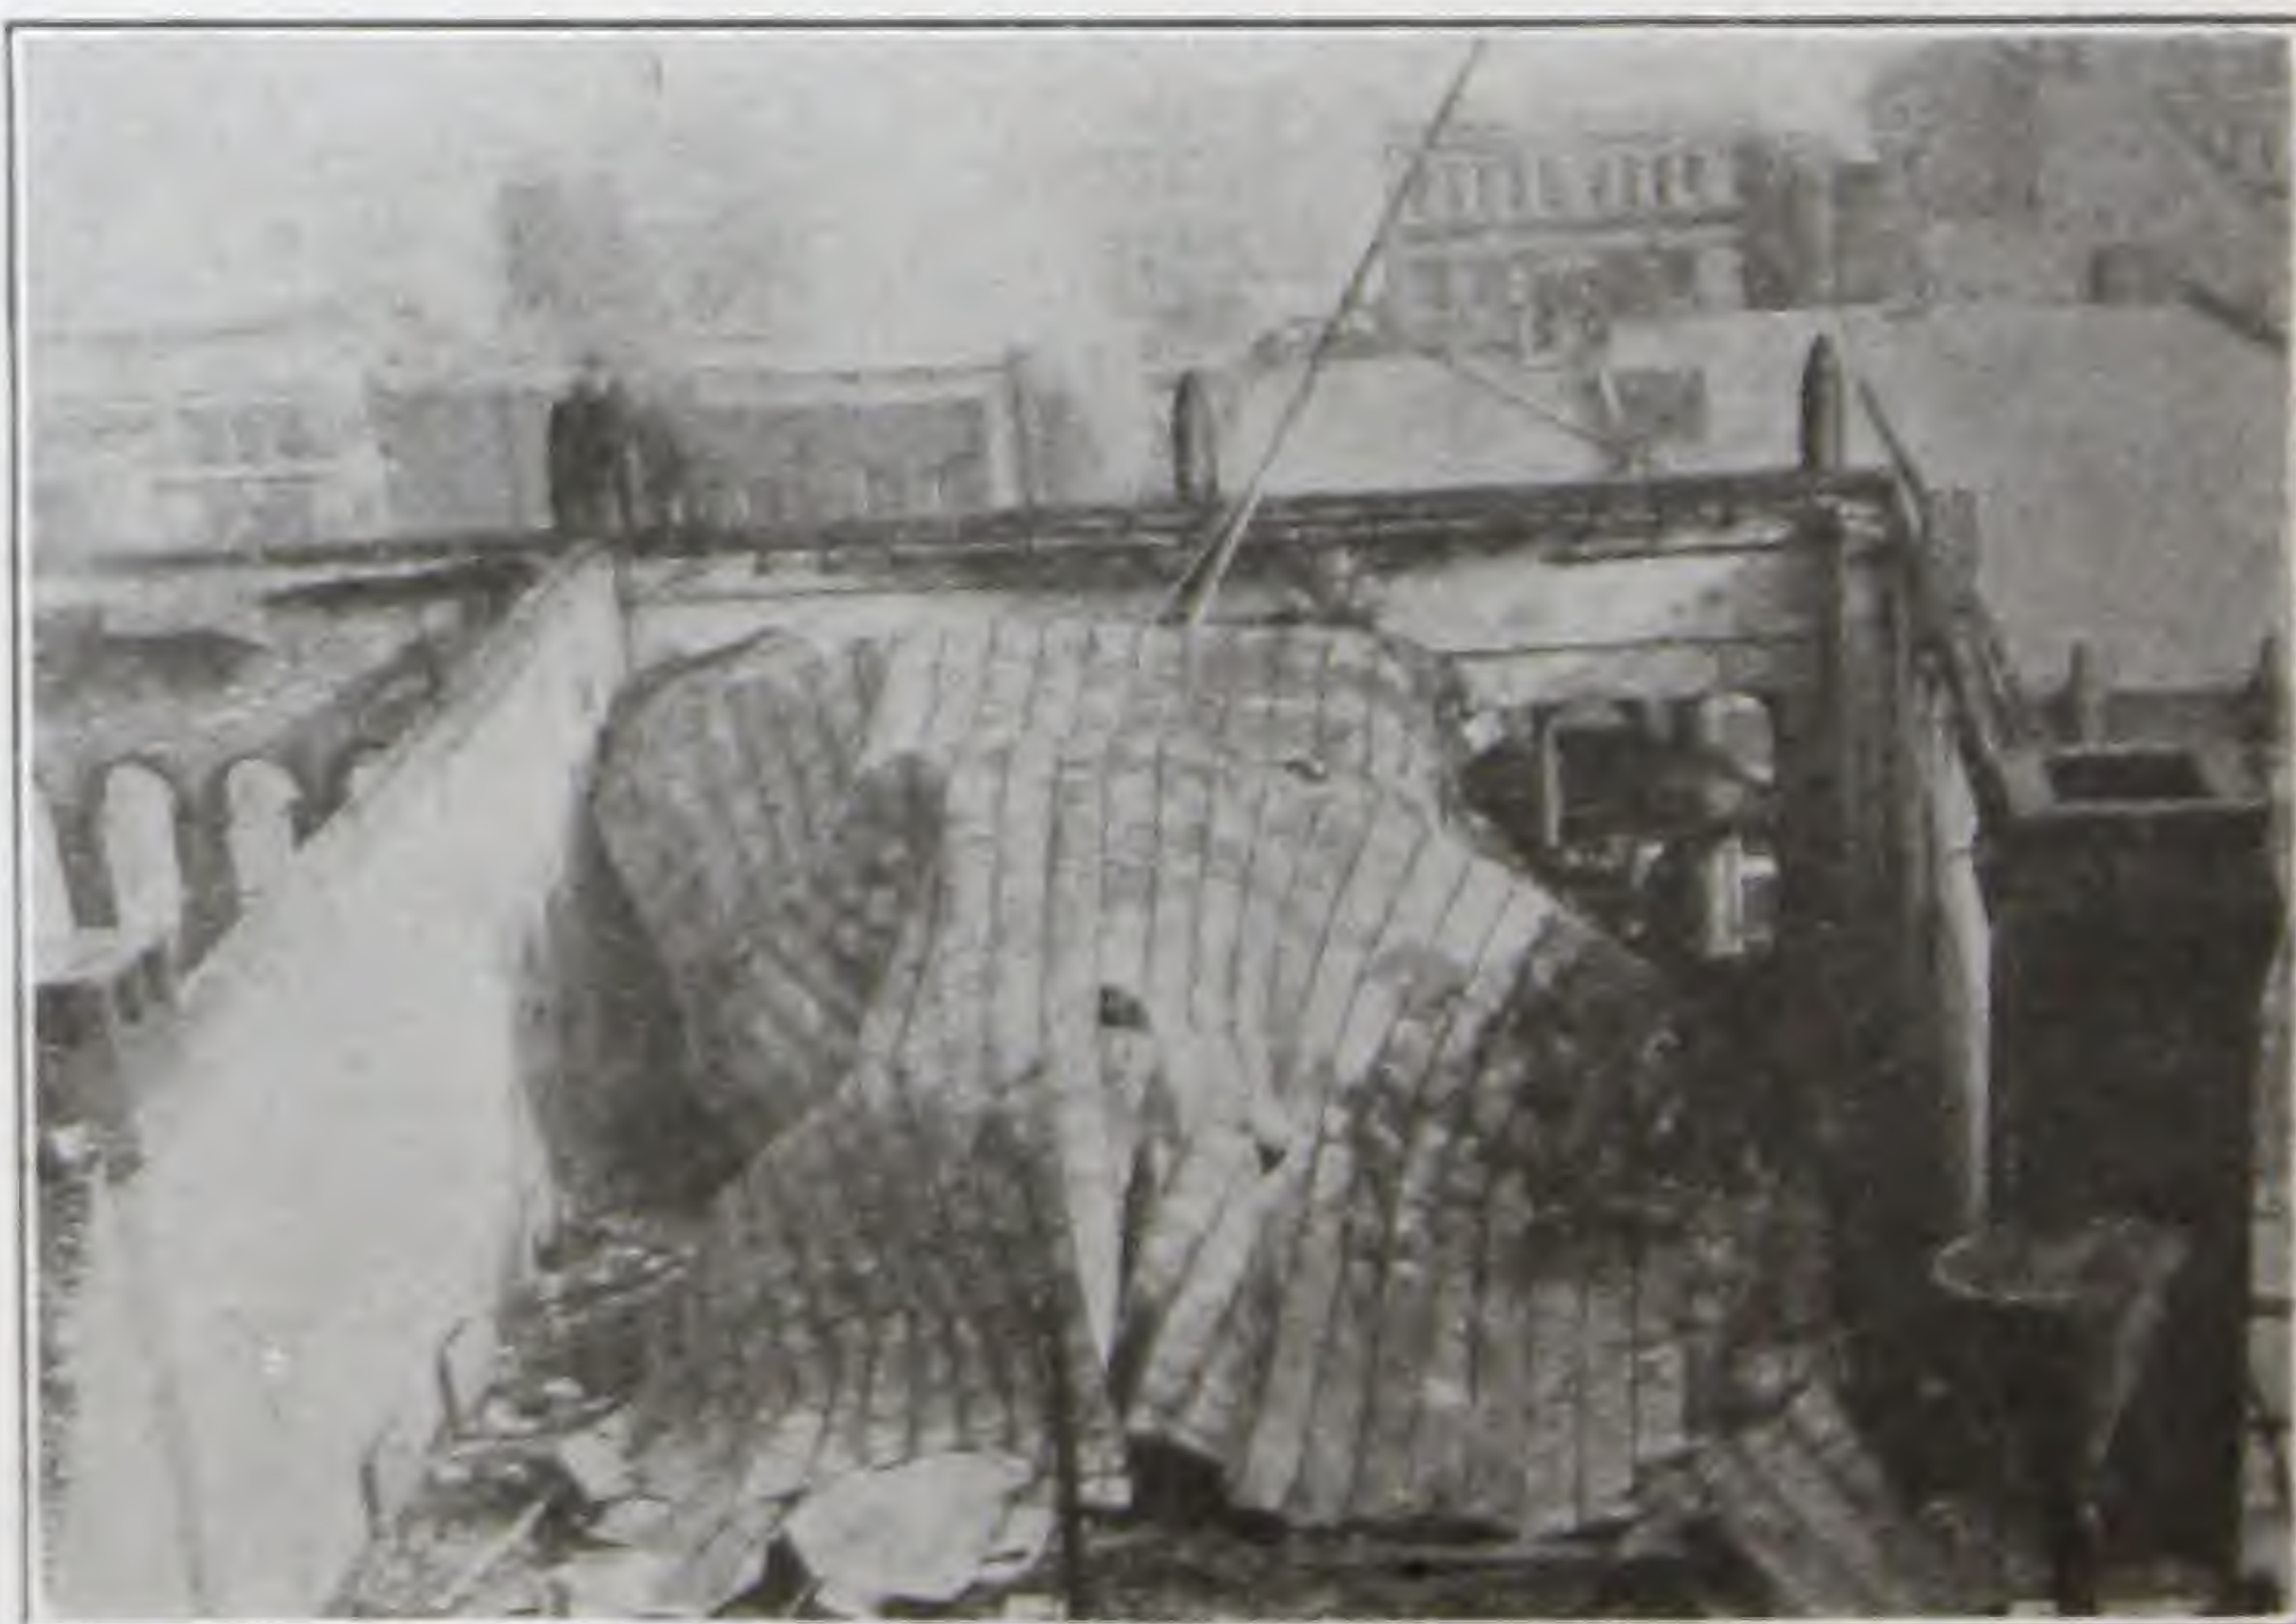
**34. ACTS AS A BLANKET:** This illustration of a recent fire in Baltimore shows how the tin roofing will often settle down like a blanket on the ruins, smothering the flames and checking the dangerous up-draft.

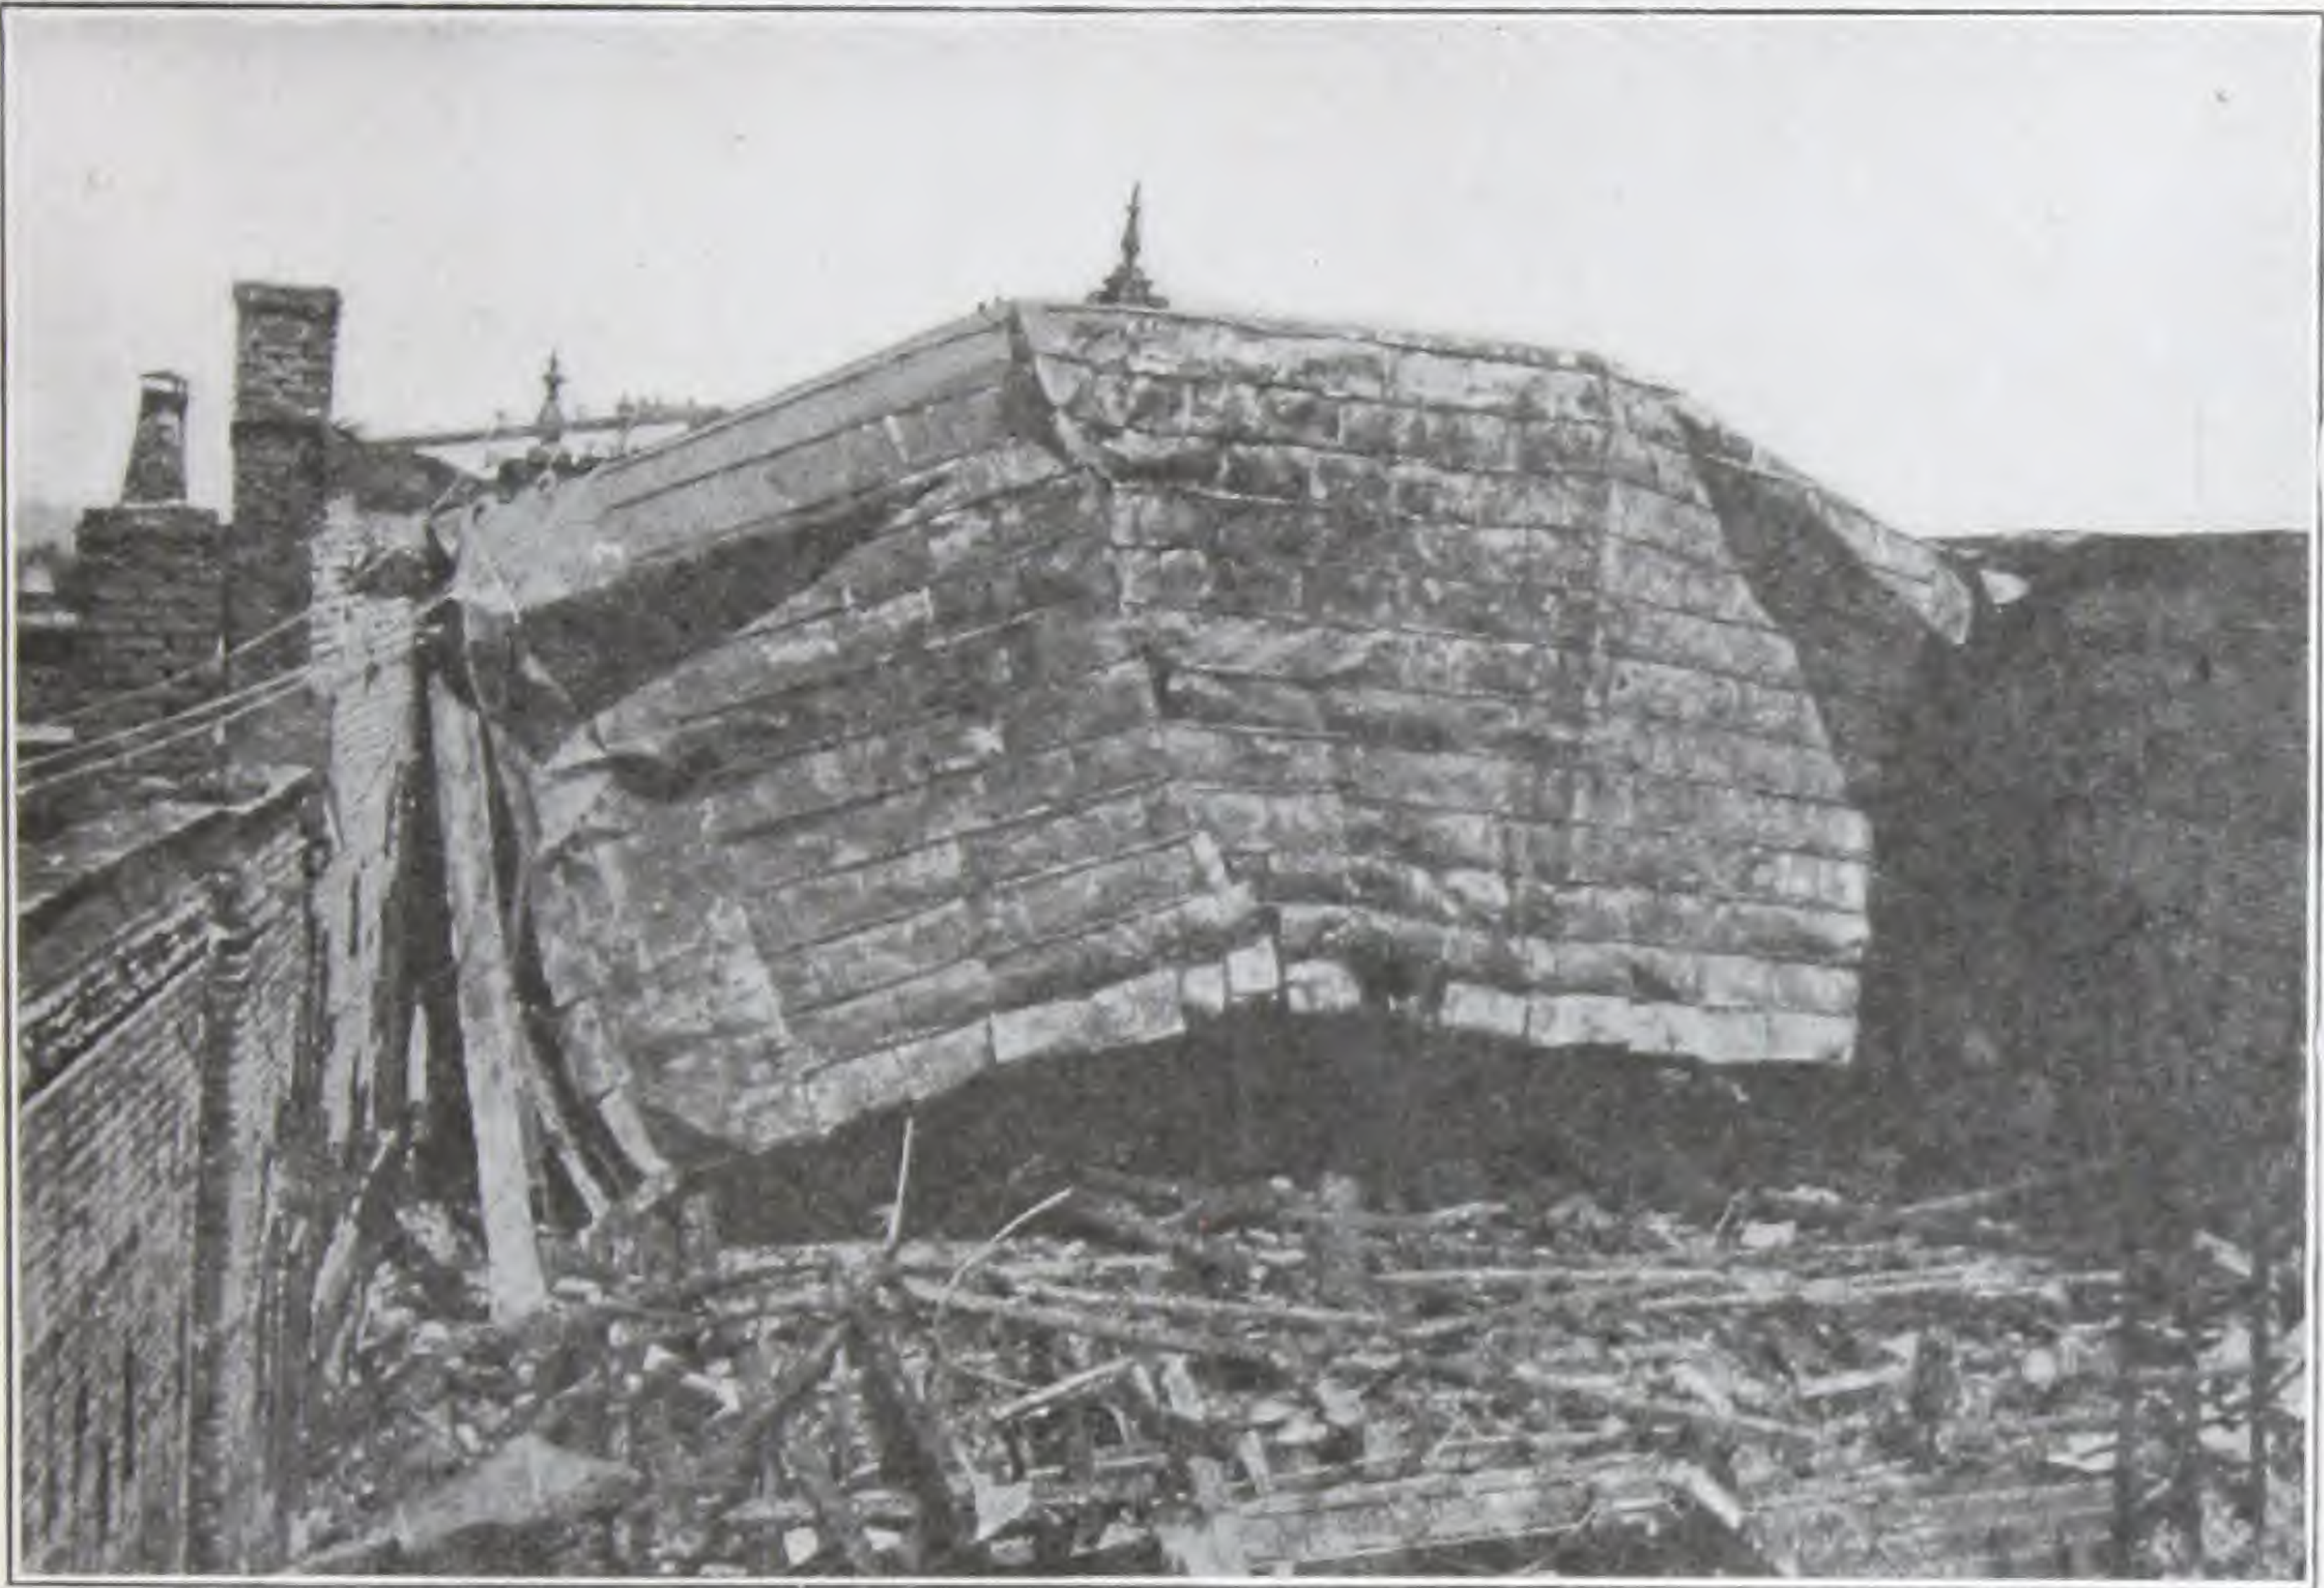
**35. PREVENTS SPREAD OF FIRE:** This view of the ruins of a recent fire in Philadelphia serves to show how well laid tin roofing will hold together and hang down like a curtain when the supports are partly destroyed. This tends to cut off the draft, holding the flames in check.

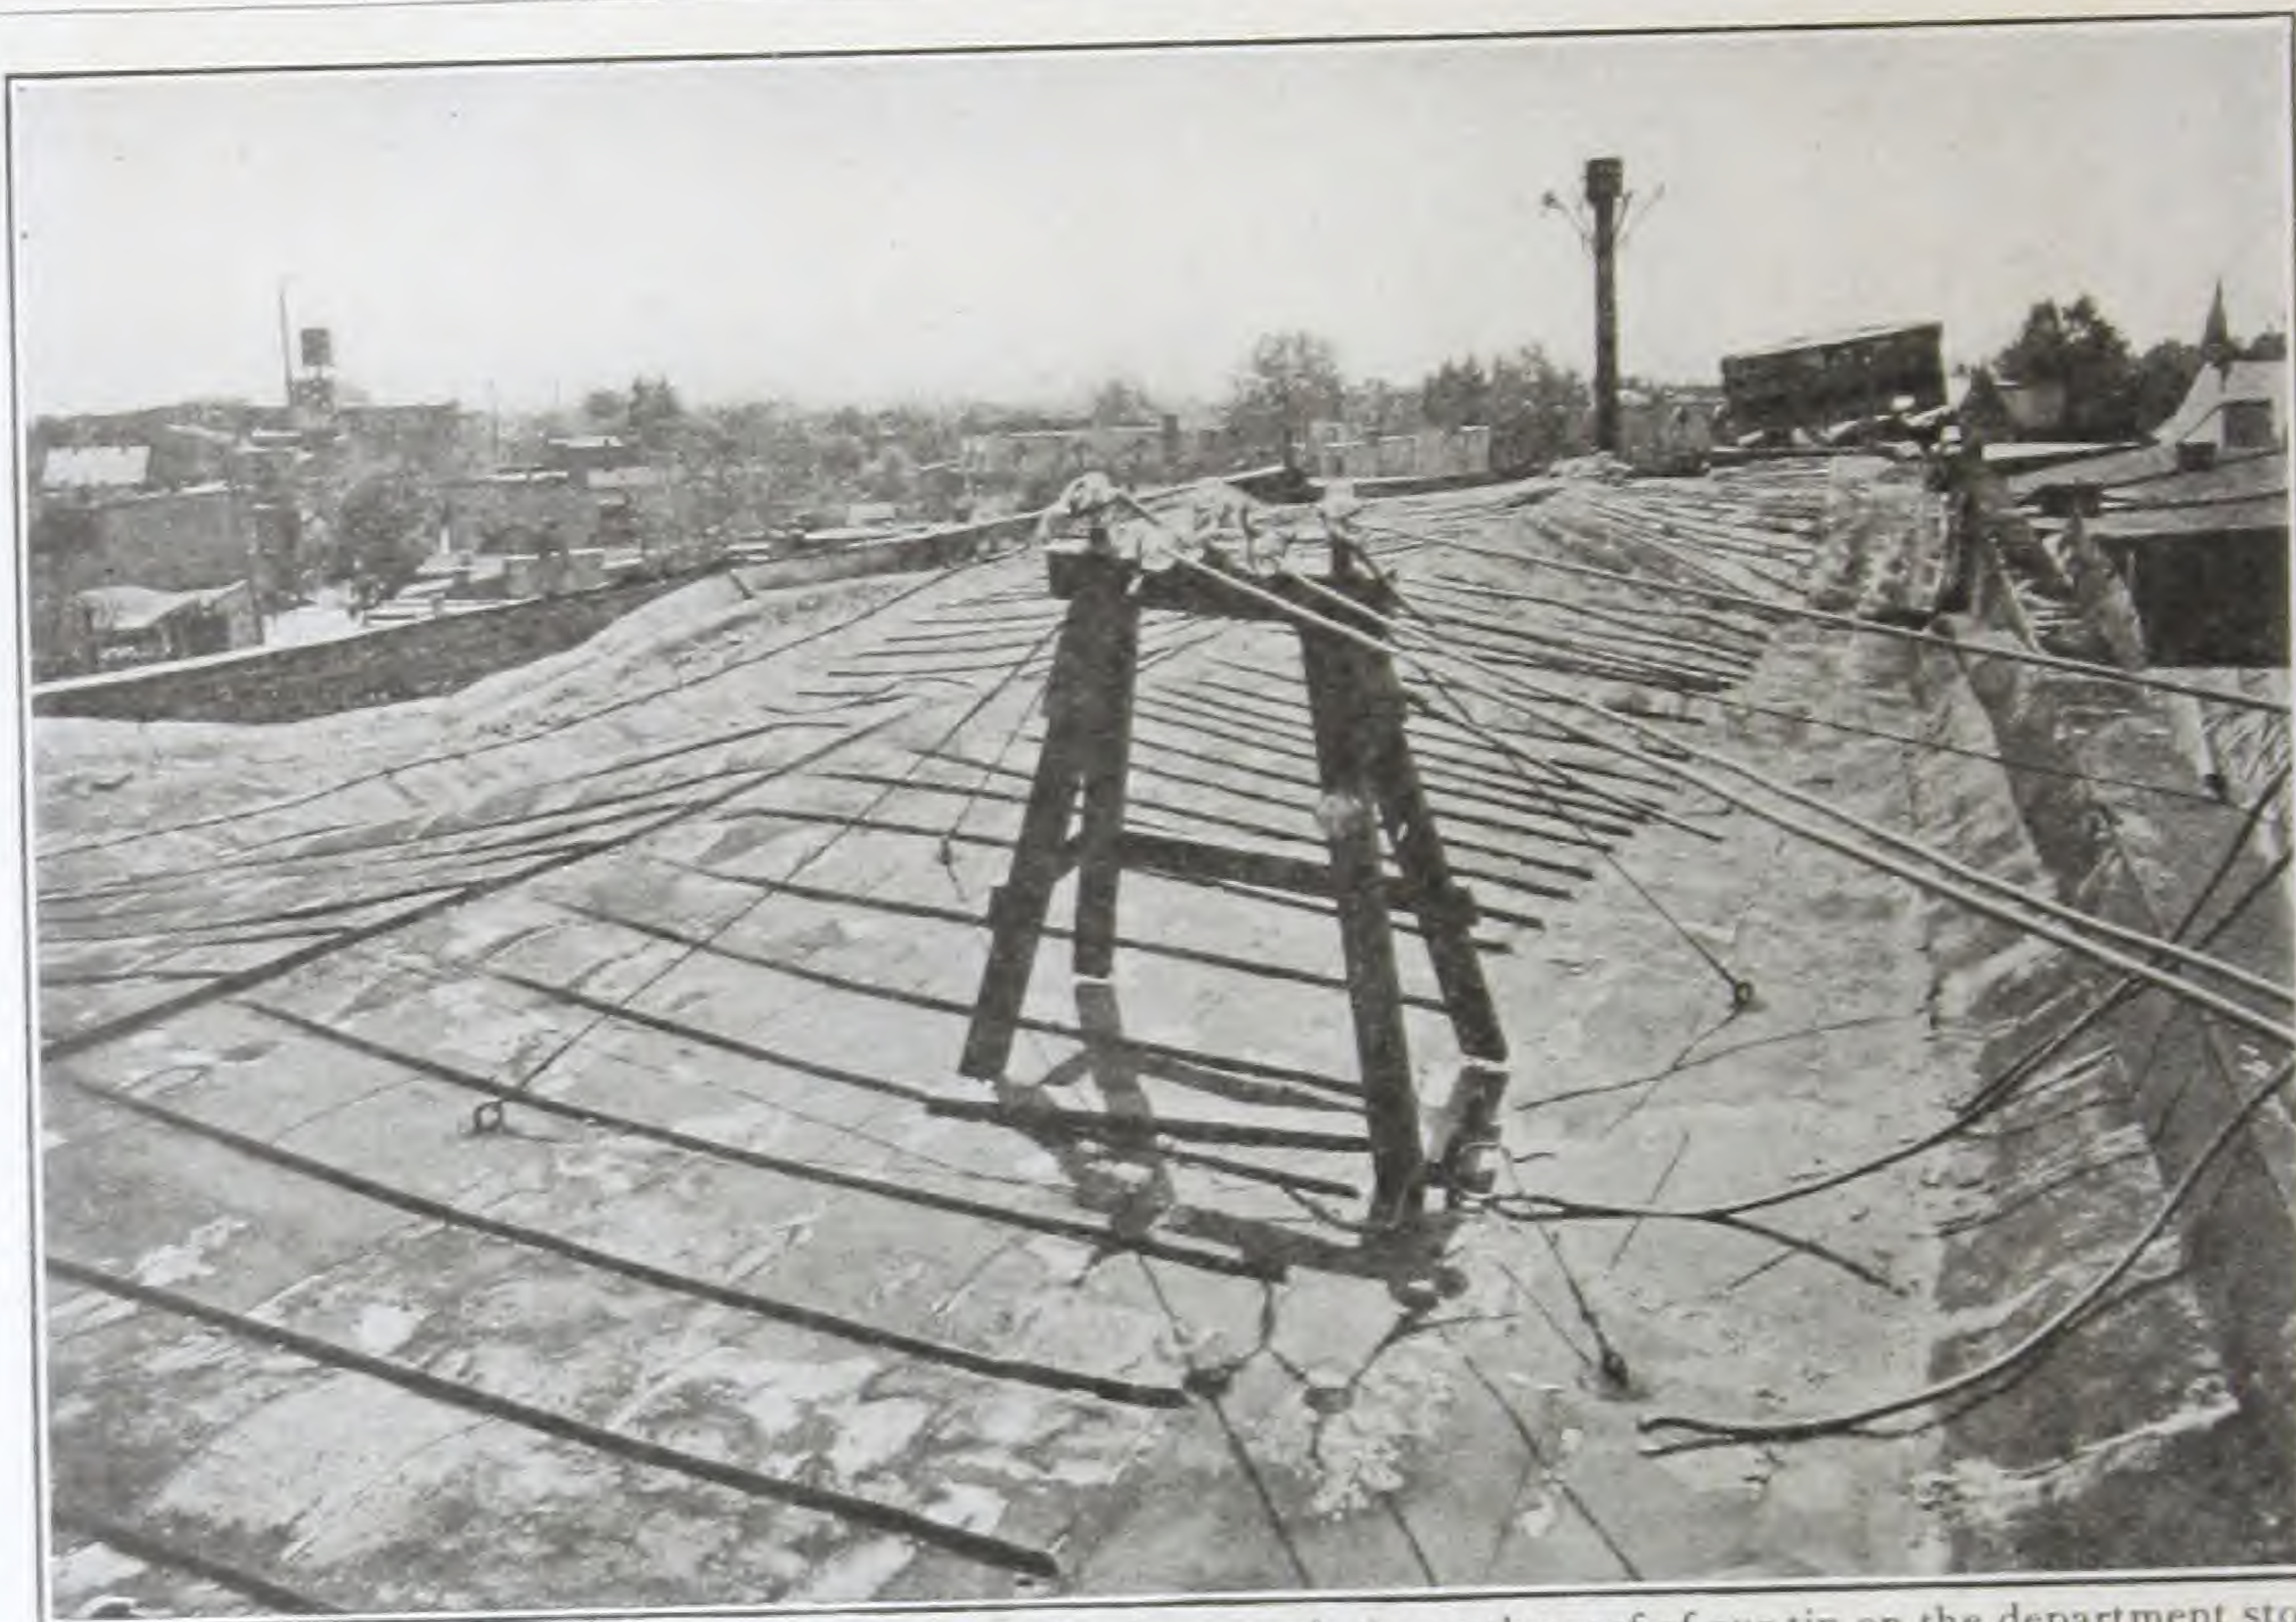
**36. PREVENTS SPREAD OF FIRE:** This photograph shows the roof of our tin on the department store of George B. Davis & Co., Philadelphia, after a fire that recently destroyed the building. The sheathing-boards under the tin roof shown in this illustration were completely burned away, leaving the tin supported only by the side walls and by a line of charred posts burned almost through, down the center of the building. *This tin roof effectively prevented the flames from breaking through, and held the fire within the original building, making it comparatively easy for the firemen to control the flames.*

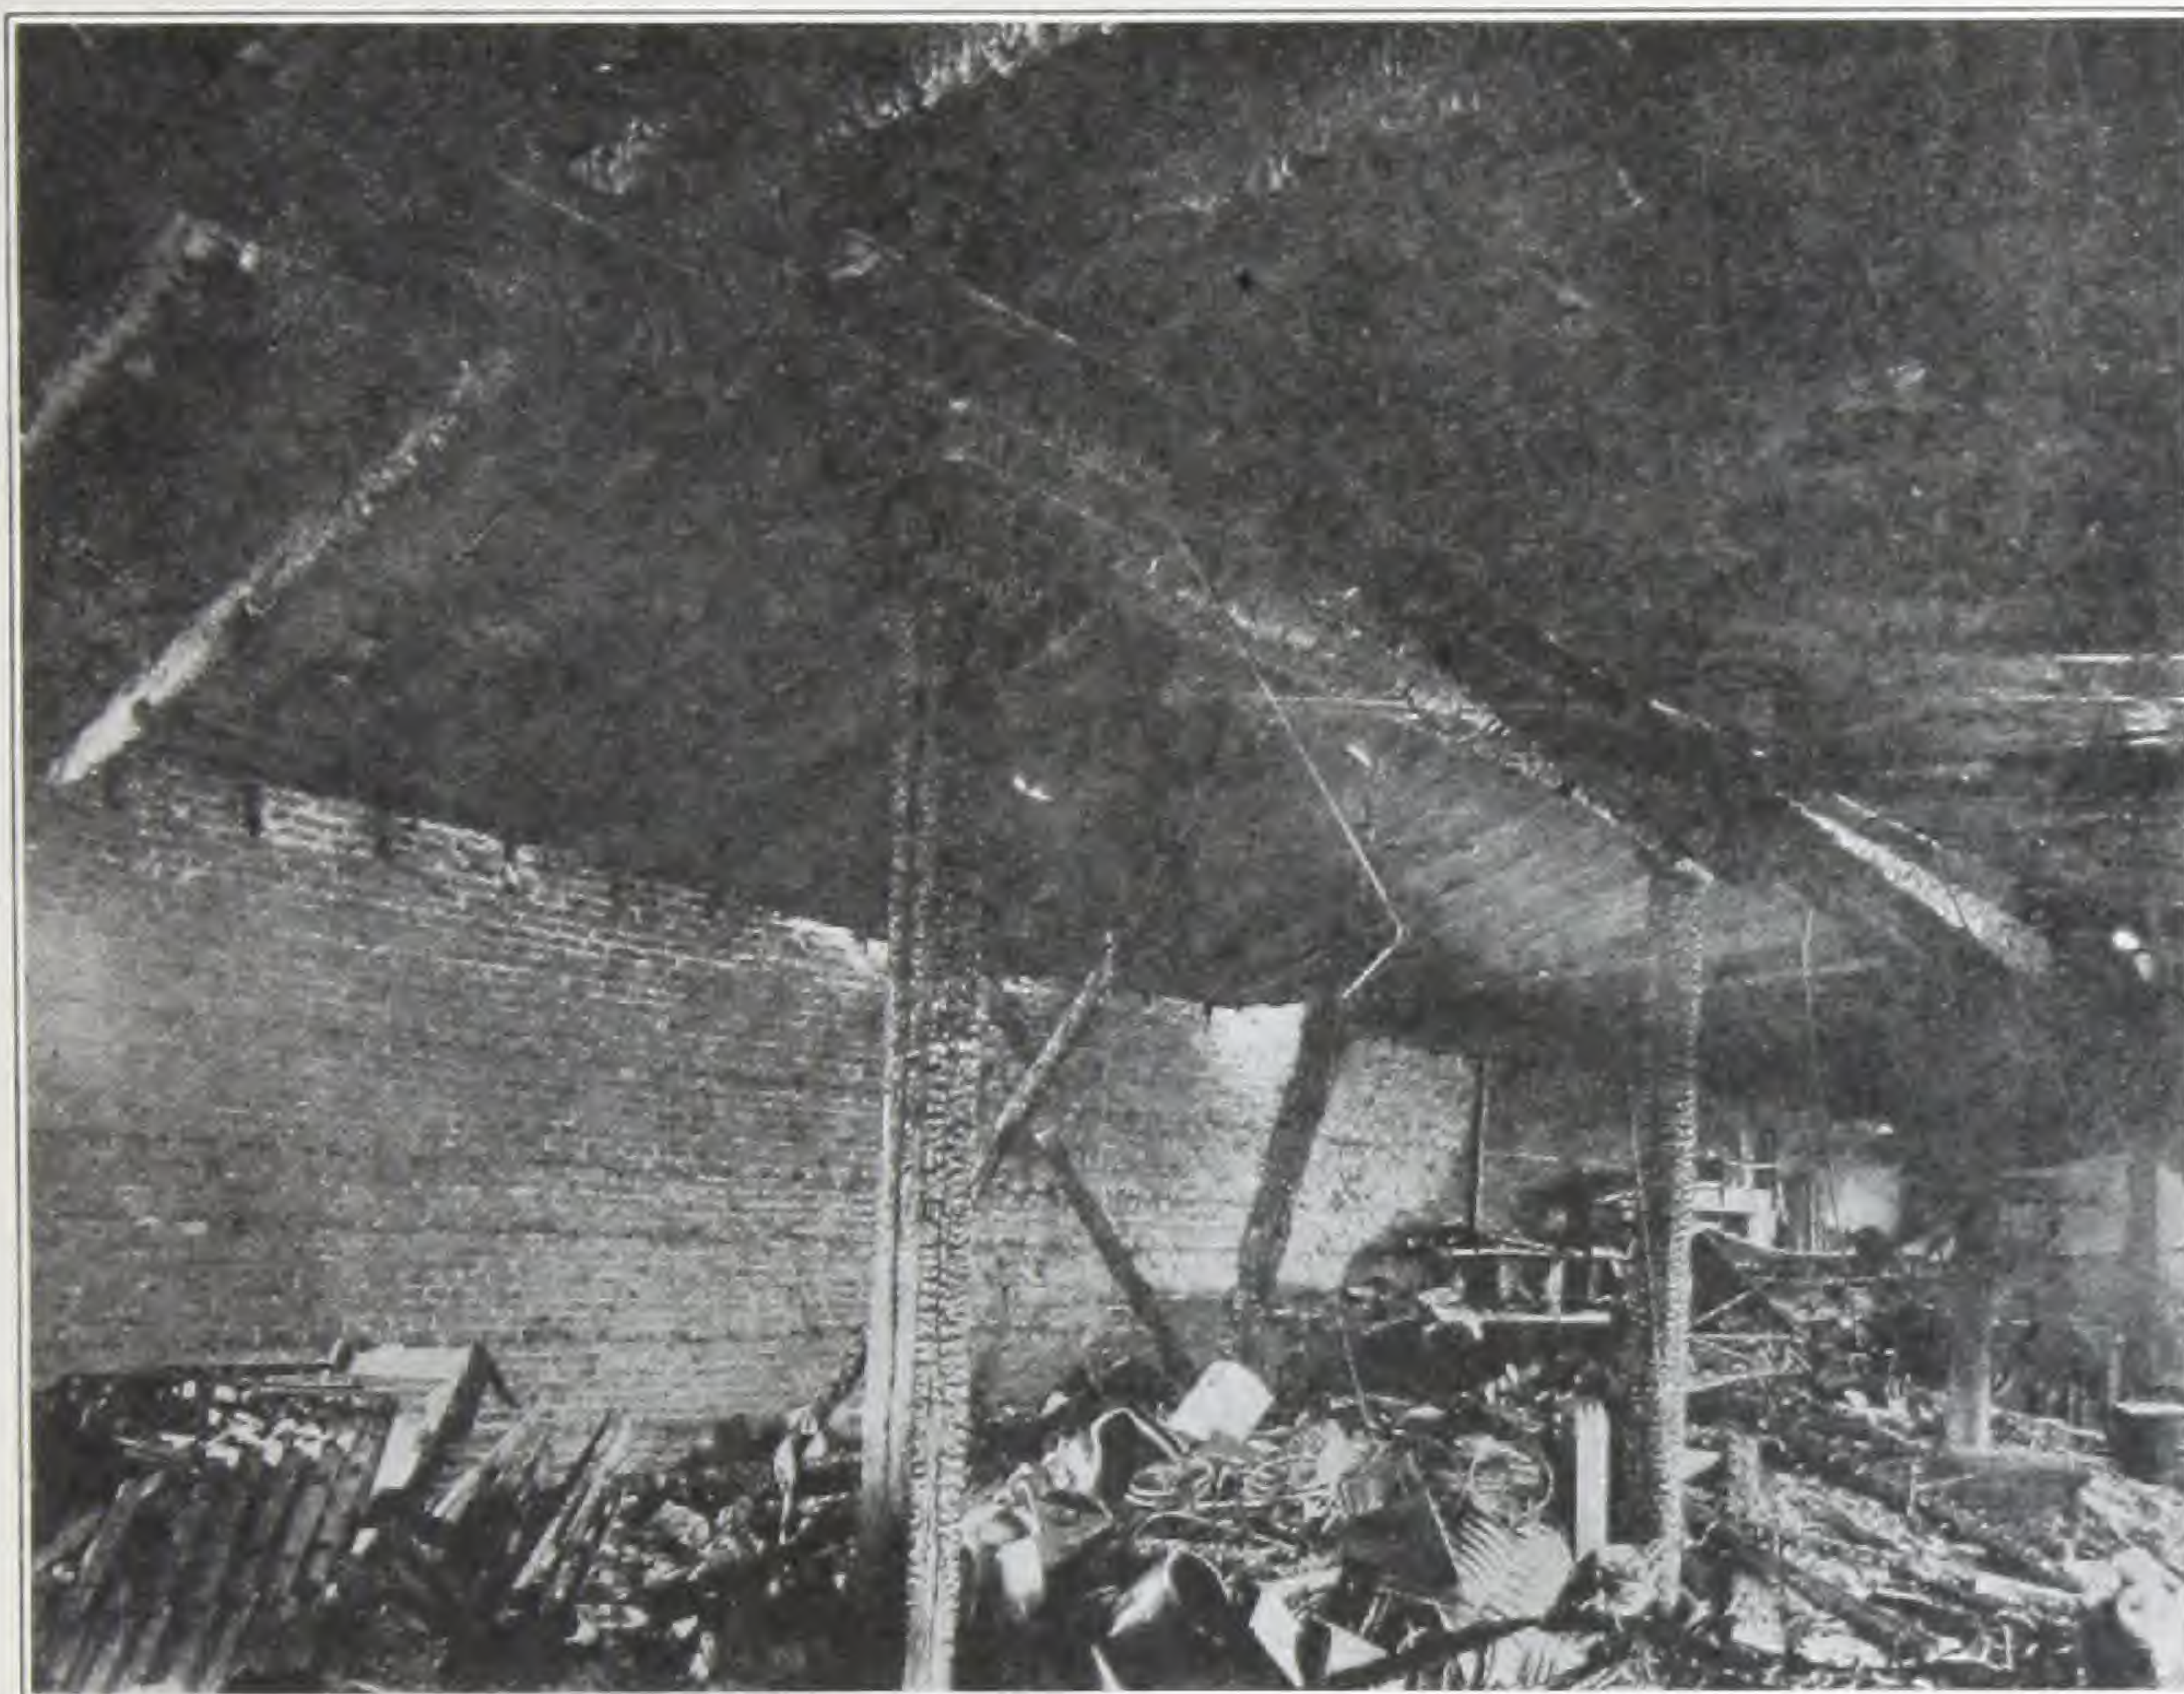
**37. PREVENTS SPREAD OF FIRE:** This view shows the under side of the tin roof shown in the preceding illustration. Note that the tin roofing remains practically intact, although the sheathing-boards below *are completely burned away*. The illustration shows clearly the under side of the tin, and the charred supporting posts and center beams. The building stands in the center of a closely built up district, and the inflammable nature of the contents made an unusually hot fire. A general conflagration was prevented by the quick work of the Philadelphia Fire Department, and, to a considerable extent, by the protection afforded by the tin roof. The owners write us that this was our tin, put on in 1835 and in 1902, giving entire satisfaction up to the time of the fire. They say: "We do not see how a better test could be arranged to show the fire protection afforded by a good tin roof to surrounding property in the case of fire starting inside the building it covers."
